LOCATION PROFILE

WEST LIBERTY FOODS, Liberty, IA – Co-op Member

PROJECT INSTALLATION - SCALEBLASTER AG-100

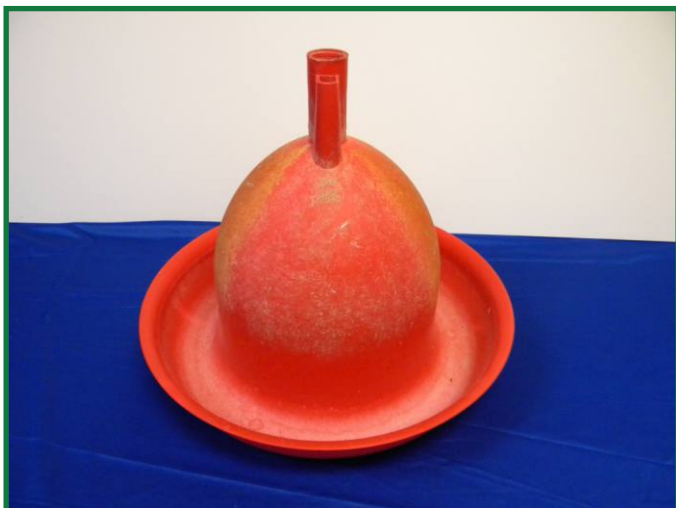
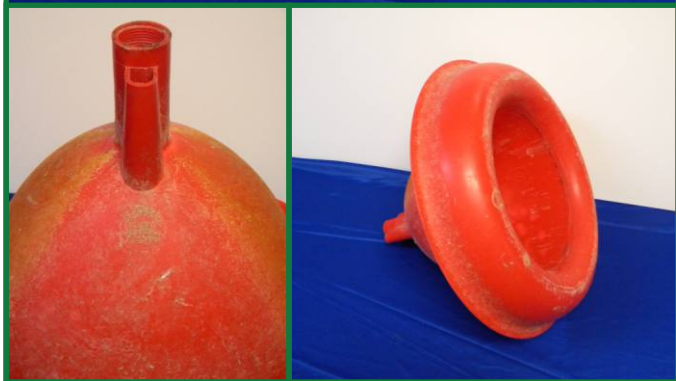
ABOVE PHOTOS - SCALEBLASTER AG-100 TREATED

- 12 WEEK FINISHING
- Powdered Calcium in trough from drying. Wipes clean
- NO SCALE ACCUMULATION ON BELL OR VALVE MECHANISM

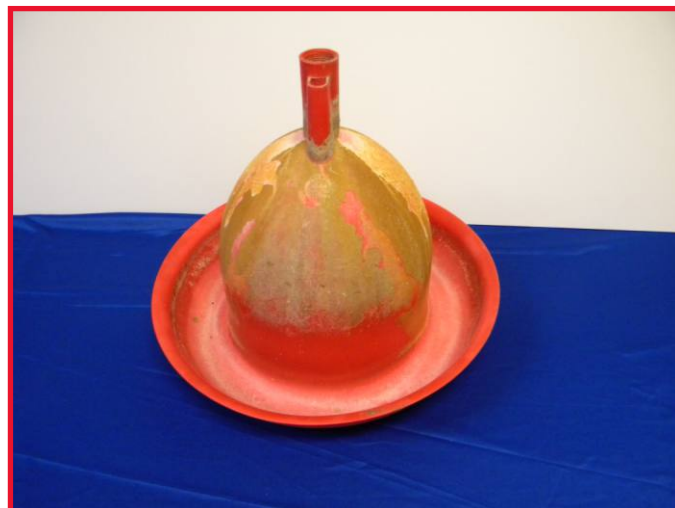
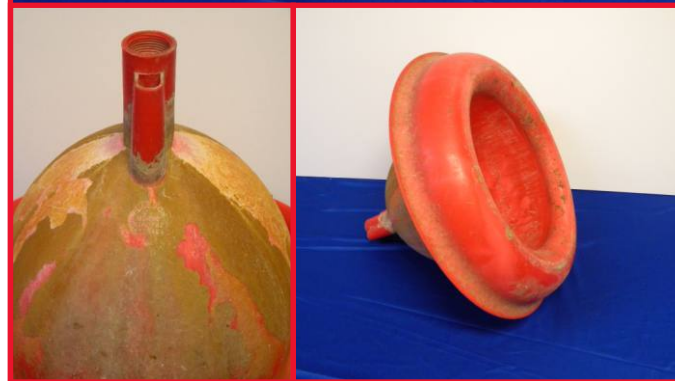
ABOVE PHOTOS - SAME BARN - NOT TREATED

- 12 WEEK FINISHING
- Scale became visible on Bell and Valve at 5 weeks
- Very heavy Scale accumulation at 12 weeks
- Drinker water flow is marginalized from 5 weeks to 12 weeks as Scale and Biofilm increasingly develop
